Prestressed Concrete Sleepers Failure Investigation Case Study

Denis Yurlov¹, Andrey Shishkin², Semion Zhutovsky²

¹*Israel Railways, Lod, Israel*

²*Technion Israel Institute of Technology, Haifa, Israel*

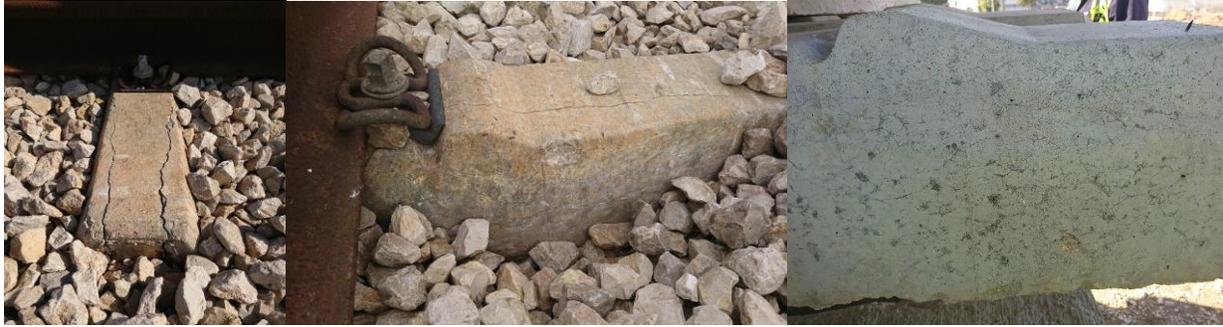
The visual inspection of the prestressed concrete sleepers revealed longitudinal cracks between 200 microns and several millimeters that in most cases passed through the prestressing cables. Cracks appeared in a variety of locations and diverse variations. An example of the characteristic longitudinal cracking of the sleepers is shown in Figure 1. Nevertheless, the cracks passed around the prestressing cable zones, reflecting corrosion of the prestressing cables causing development, growth, and opening of these cracks. In addition, on the uninstalled concrete sleepers, cracking was observed as well, illustrating net cracking pattern on its surface as shown in Figure 1 suggesting the failure cause could be either alkali-silica reaction of aggregates or ettringite formation caused by either internal or external sulfate attack.

Figure 1. Characteristic longitudinal cracking on top (left) and side surfaces (center). The net cracking pattern on the surface of a new concrete sleeper (right).

The presence of ettringite in the concrete sleeper suggests delayed ettringite formation since it's likely to exist only either in fresh concrete, or at a very early age then ettringite quickly transformed to monosulfate. One of the explanations of presence of ettringite in the sleeper is high curing temperature [4], i.e. exceeding 80 °C. In this case ettringite crystals could form in the concrete at later ages after hardening while expanding. Since the concrete can not resist the expansive formation of ettringite the net cracking pattern is formed (Figure 1, right above).

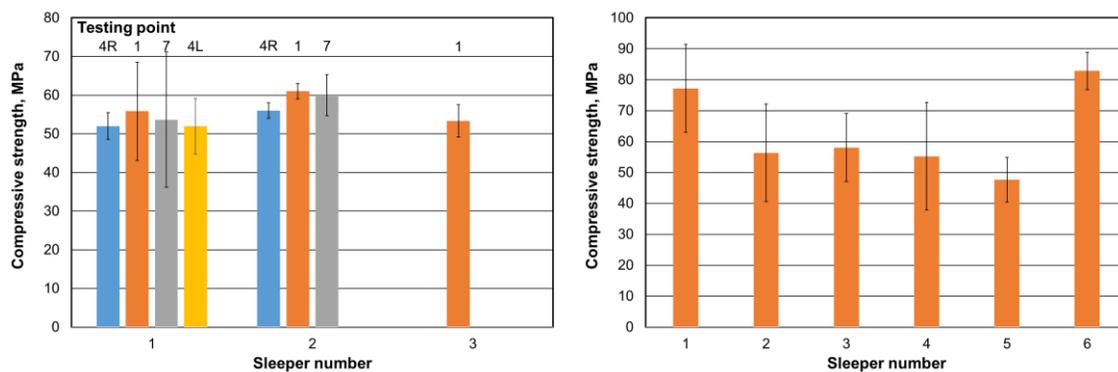
The NDT was done by Schmidt hammer and Ultrasonic Pulse Velocity (UPV) on several sleepers. These results are graphically summarized in Figure 3 below. The error bars in these figures indicate the confidence interval of 95%, which corresponds to twice Standard Deviation (SD).

The field tests were conducted in different zones of the sleepers as indicated in Figure 2 below, as well as, on different sleepers conditions such as new, partially cracked, and fully cracked sleepers. The results of field testing confirm that mechanical properties of concrete used for sleepers production are satisfactory and therefore the reason for failure most probably is not of mechanical origin.

Figure 3. Evaluation of compressive strength based on in situ Schmidt rebound hammer test (left) and UPV measurement (right)

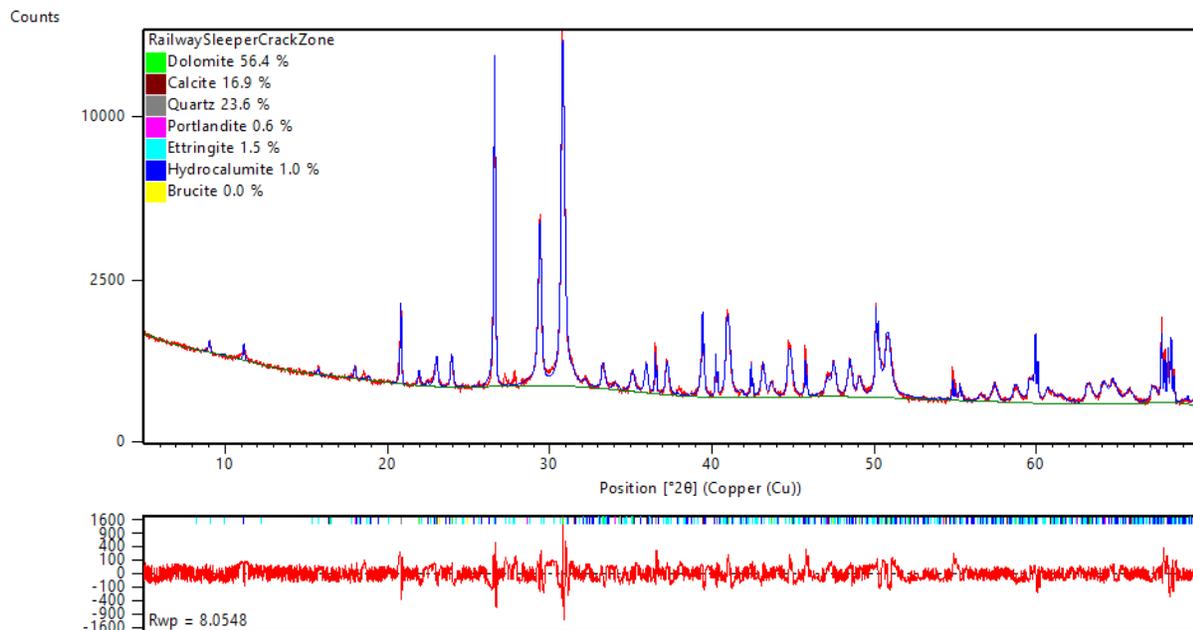
The mineralogical composition was determined on three different samples taken from three locations of the cracked concrete sleeper. The summary of the composition is given in Table 1 below and an example of the X-ray Diffractogram (XRD), including Rietveld fitting curves, and difference plot are shown in Figure 4 below.

This test reveals the concentration of Hydrocalumite and Ettringite. Hydrocalumite, also known as Friedel's salt, is chloride salt that is formed when chlorides come into contact with cement paste. According to the international standards [1,2,3], chlorides are thoroughly excluded from concrete composition.

Figure 4. XRD diffractogram of concrete from crack, edge and center zone of sleeper
