Prestressed Concrete Sleepers Failure Investigation Case Study

Denis Yurlov¹, Andrey Shishkin², Semion Zhutovsky²

¹*Israel Railways, Lod, Israel*

²*Technion Israel Institute of Technology, Haifa, Israel*

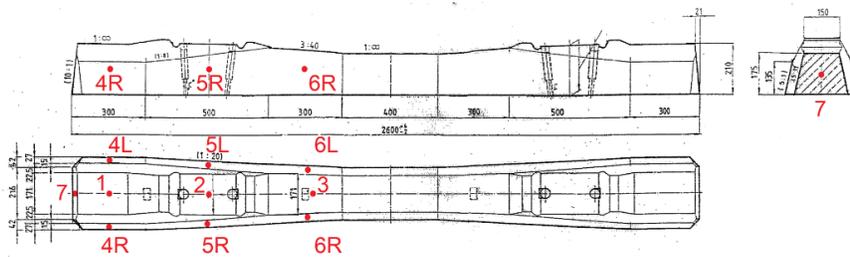
Figure 2. NDT testing points layout

The field tests were conducted in different zones of the sleepers as indicated in Figure 2 below, as well as, on different sleepers conditions such as new, partially cracked, and fully cracked sleepers. The results of field testing confirm that mechanical properties of concrete used for sleepers production are satisfactory and therefore the reason for failure most probably is not of mechanical origin.
